SUBJECT: Analysis of the Apollo Entry  
Monitor System's  $\Delta V$  Counter  
Case 320

DATE: April 16, 1969

FROM: D. O. Baechler  
R. Lindner, BTL

ABSTRACT

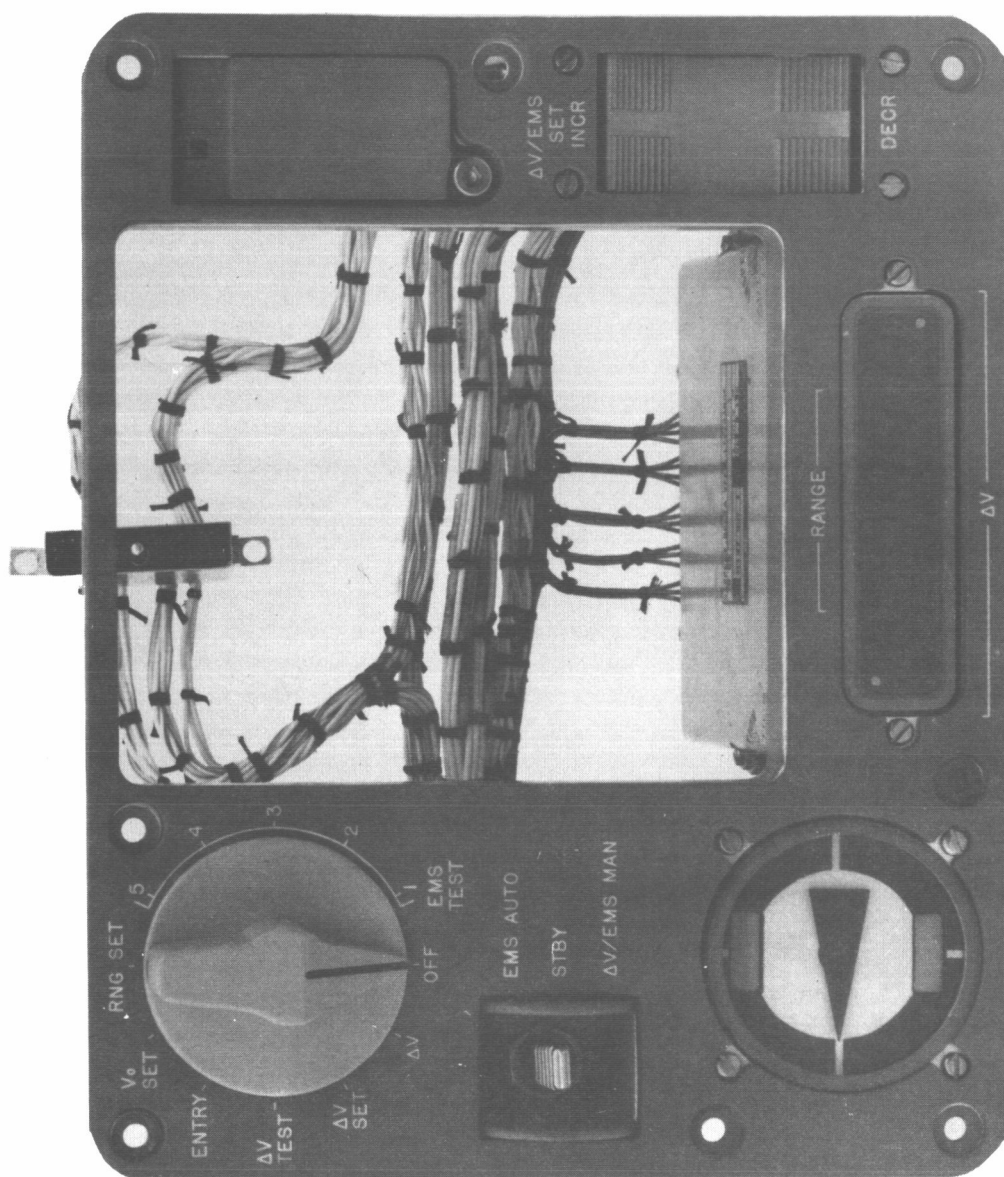
FIGURE 1 - ENTRY MONITOR SYSTEM PANEL

On the EMS panel are a mode switch with positions STNBY, AUTO and MANUAL; a function switch with positions EMS TEST 1 through 5, RNG SET,  $\Delta V_0$  SET, ENTRY,  $\Delta V$  TEST,  $\Delta V$  SET,  $\Delta V$  and OFF; and a  $\Delta V$ /EMS SET switch with the sequence of positions FAST UP, SLOW UP, OFF UP, OFF DOWN, SLOW DOWN, and FAST DOWN. Figure 1 shows the EMS panel with the scroll assembly removed.
